Manhole Inspection Summary

Manhole # S49I__005MH

Location Address: **rear 512 s glover st**

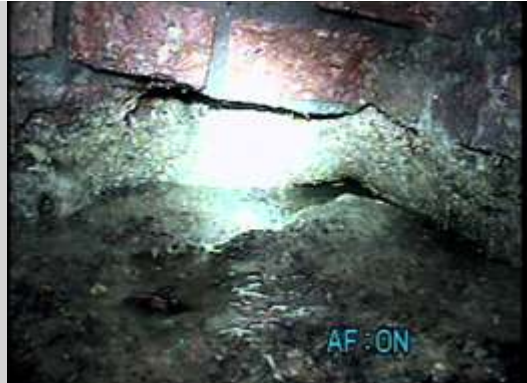
12 O'Clock Outflow

8 in. Circular Gravity Sewer
Pipe Out @ 12 O'Clock

Pipe Material: **Clay** ☐ Pipe Lined

Deposits: ☒ None ☐ Mud ☐ Sludge ☐ Debris ☐ Grease

Infiltration: **None** Pipe Seal Cond: **Unknown**

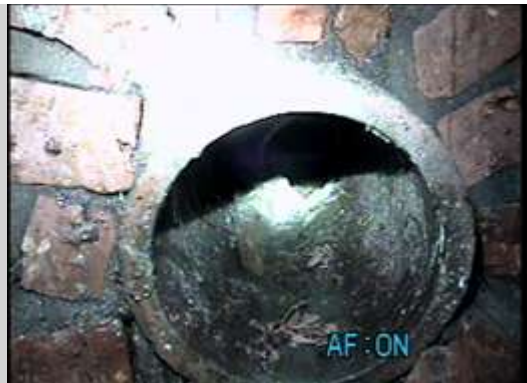
3 O'Clock Inflow

8 in. Circular Gravity Sewer
Pipe In @ 3 O'Clock

Pipe Material: **Clay** ☐ Pipe Lined

Infiltration: **None** Pipe Seal Cond: **Unknown**
